The development of artificially created breaches in an embankment as part of a managed realignment, Freiston Shore, UK.

SYMONDS, A. and COLLINS, M., 2007. The development of artificially created breaches in an embankment as part of a managed realignment, Freiston Shore, UK. *Journal of Coastal Research*, SI 50 (Proceedings of the 9th International Coastal Symposium), 130 – 134. Gold Coast, Australia, ISSN 0749.0208

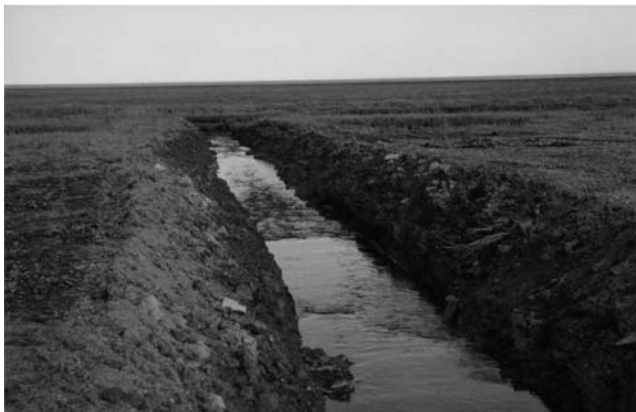
Figure 6. A seaward view of the channel within Breach 1, shortly after it was created (22/08/2002).

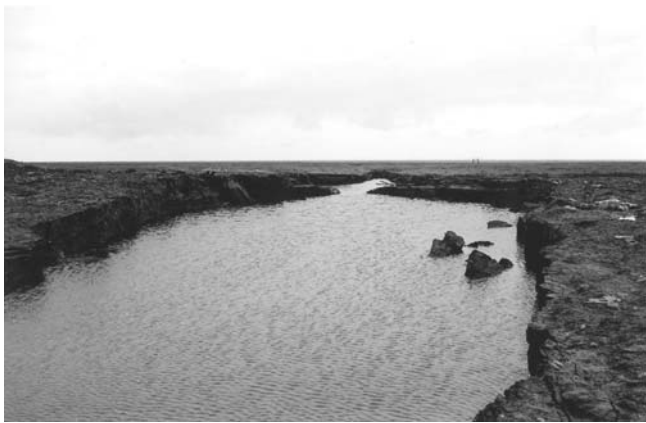
Figure 7. A seaward view of the channel within Breach 1, two months after the initiation of the managed realignment scheme.
