Quality Assessment of the Armourstones for Some Black Sea Rubble Mound Breakwaters, Turkey

OZDEN, U.A. and TOPAL, T., 2007. Quality assessment of the armourstones for some Black Sea rubble mound breakwaters, Turkey. *Journal of Coastal Research*, SI 50 (Proceedings of the 9th International Coastal Symposium), 190 – 194. Gold Coast, Australia, ISSN 0749.0208

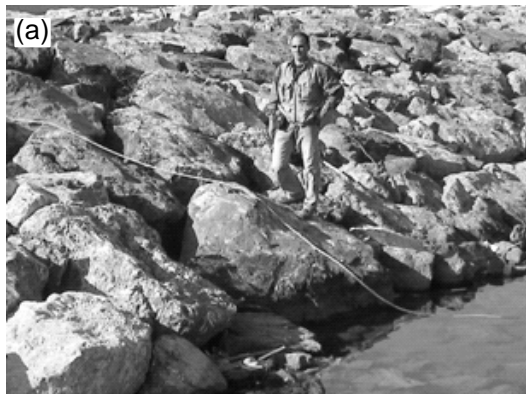
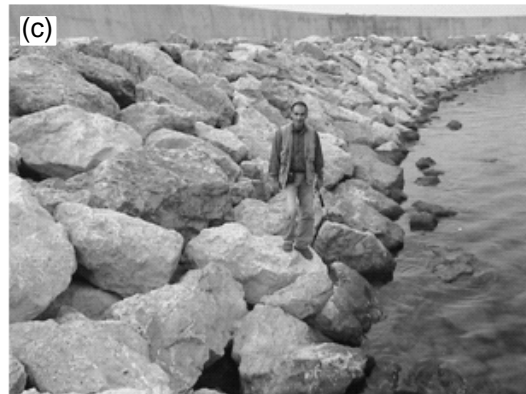
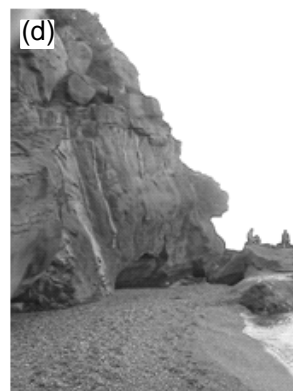
Figure 2. Field performances of (a) Kavakdere and Kavukkavlagi limestones in Alapli rubble mound breakwater; (b) the Cömlekcikuyu andesite in Hisaronu rubble mound breakwater; (c) the limestone in Tarlaagzi rubble mound breakwater; (d) the Kiran sandstone at the coast to be used as potential armourstone

The two rock durability and quality evaluation techniques used in this study yield generally consistent results, although some differences exist. The field (in-service) performances of the stones are shown in Figure 2. The three limestones are good in quality, with no deterioration in terms of their integrity and shape of the blocks being observed after two years of service in the breakwaters. The andesite is good to marginal. Local spalling (1-2 mm thick) of the andesite blocks at the outer surface of the stones is observed after two years of service. However, the sandstone is poor. The natural exposure of the sandstone at the coast is severely

deteriorated in the form of material loss, with cavity formation due to the coastal processes.
