# Northern Gold Coast Beach Protection Strategy: Improving beach width

## How the Northern Gold Coast Beach Protection Strategy Works

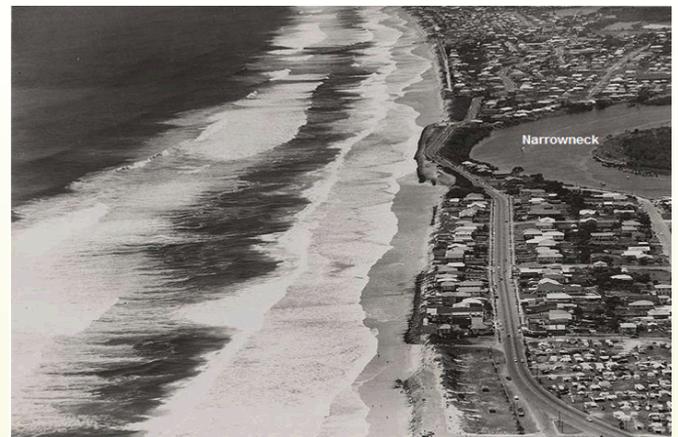
Figure 1. Narrowneck mid-1950s (Source: GCCC)

Narrowneck is a stretch of coastline between Surfers Paradise and Main Beach. The name Narrowneck refers to the narrow stretch of foreshore between the surf and the Nerang River (Figure 1). It has a history of high levels of erosion during storm events. In 1999 construction of an artificial reef began at Narrowneck as part of the Northern Gold Coast Beach Protection Strategy. The reef was completed in 2000.

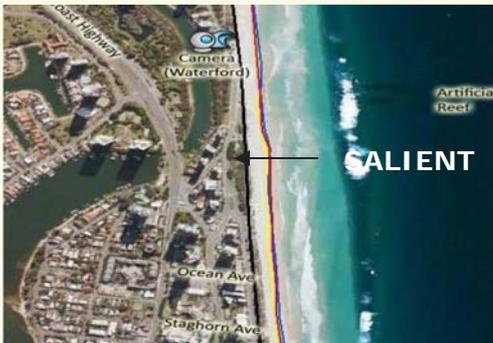
Figure 2. Salient visible in an aerial photograph (Source: Google Maps, 2009)

As part of this strategy, the beach at Narrowneck was nourished with over one million cubic metres of sand. This sand was largely dredged from Marine Stadium, to the North. A temporary pipeline was placed down Seaworld Drive and through the dune corridors to facilitate this process. The artificial reef was designed to decrease wave energy and thus the potential for storm waves to strip the newly placed sand off the upper beach. Specifically, this occurs when waves break and dissipate across any submerged structure. This coastal control structure also traps sand moving along the coast, creating a build up of sand on the beach to the south of the reef (refer to *Longshore drift: Coastal process on the Gold Coast information sheet*). This creates a salient (bulge) where the coastline is protected by the reef, as is evident in Figures 2 and 3.

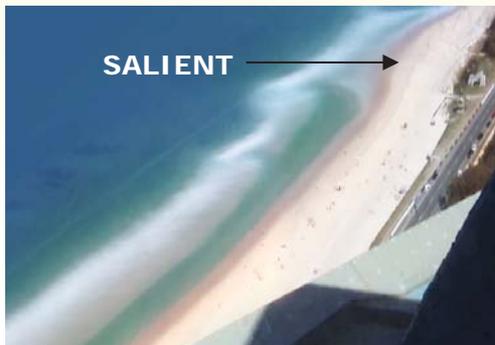
Figure 3. Salient visible in Digital Timex image captured 27 September 2010 by Coastal Coms

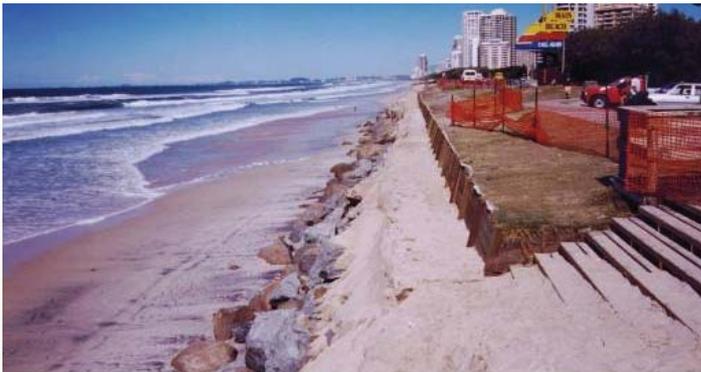
Figure 4. Beach profile at Narrowneck in 1996, before artificial reef construction (Source: GCCC)

Extensive digital imagery, hydrographic survey and observational monitoring tells us that beach widening has been achieved. Since construction, the beach at Narrowneck has widened by about 40 metres, and maintained this width for over a decade (Figures 4 and 5).

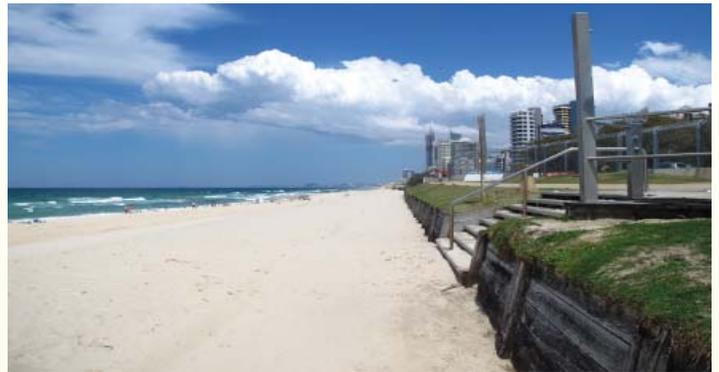
Figure 5. Beach profile at Narrowneck in 2010, a decade after artificial reef construction (Source: GCCC)

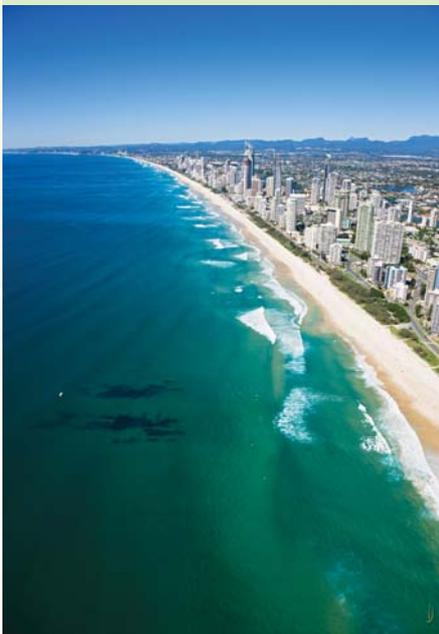
Aerial view of the reef looking south along the coast (Source: Skyepics 2011)

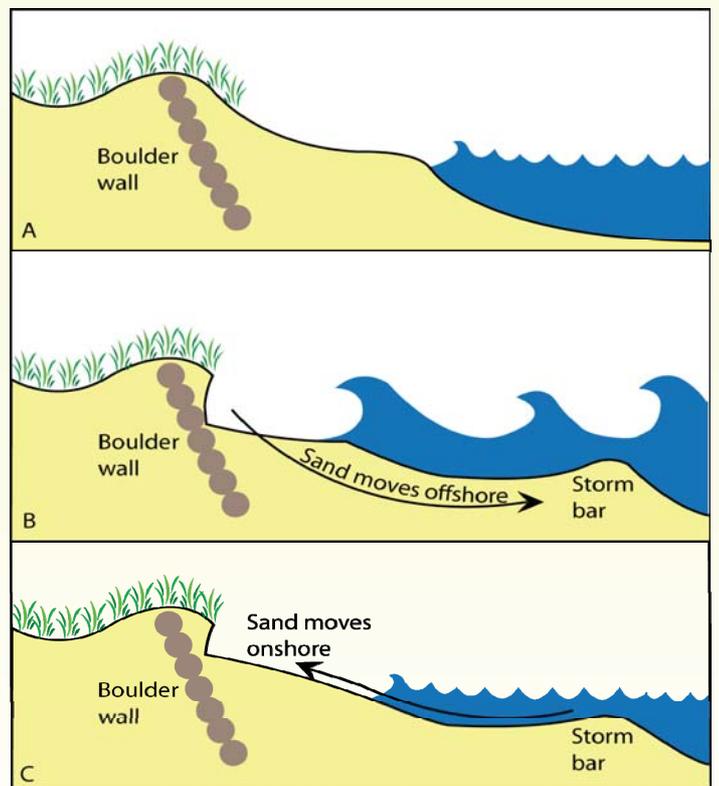
Figure 6. Beach erosion and accretion  
 A) Normal beach profile  
 B) During storm conditions, larger waves result in sand eroded from the beach and the formation of a storm bar  
 C) During calm conditions, sand from the storm bar is transported back onto the visible beach

The beach shape at Narrowneck appears to have reached an equilibrium (or ideal) because it responds naturally to and recovers from storms. Some erosion is expected in extreme events; however, when this occurs the reef is expected to help the beach recover in months, rather than years, see Figure 6.
