*Proceedings of the Society
of Architectural Historians,
Australia and New Zealand
30, Open*

Opening the Archive

The New South Wales Forensic Photography Archive as Evidence of Architectural History

Jennifer Preston

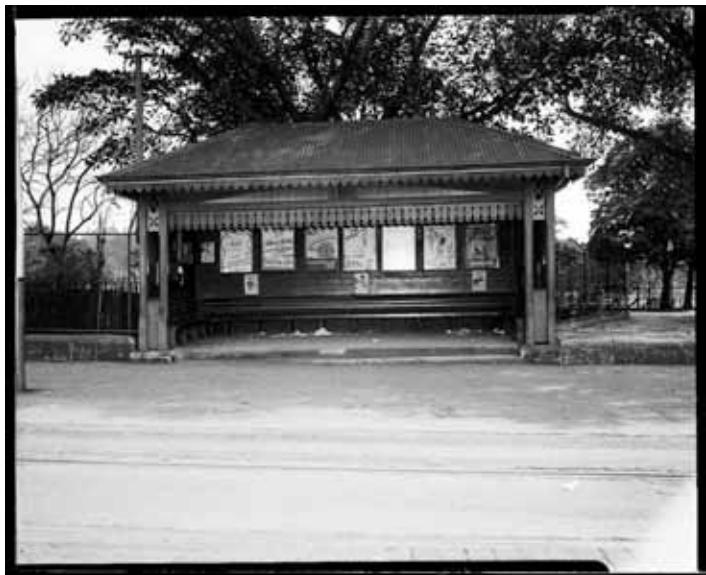
Figure 1. Site of Assault. Tram shelter on City Road. Details unknown.

The first image is of a tram shelter which was located on City Road at the edge of Victoria Park near Sydney University. This could almost be the photograph of an architectural photographer: black and white, dramatic, clearly showing the architectural detail of the timber fretwork, corrugated iron roof and the skilled work of the carpenter's timber seat. Like many architectural photographs there are no people. Only the collection of posters on the rear wall, the handbills pasted on the backrest of the seat and the rubbish accumulated around the floor of the shelter tells us this has been a recently inhabited space. The tram lines in the foreground promise it will be inhabited again, indeed removed from its criminal context as the site of an assault one might think that the photographer had just missed the tram.

This photograph is, I believe, in terms of public space architecture an important one, because while much has been written on the rolling stock of Sydney's tramway system, the various routes, the track infrastructure and the people who operated it there has been almost no attention paid to the built form that it generated.²¹ This built form in its day was extensive; tram sheds, carriage works and tram stop shelters, but it was utilitarian and did not attract the fascination of the transport technology it facilitated. There are other photographs that show tram shelters but they are usually in the context of a more general street scene or as a backdrop to another photographic subject. This image is a portrait of the tram shelter itself, the design suggesting it was built in the early days of the electric trams in Sydney, the first decade of the twentieth century.

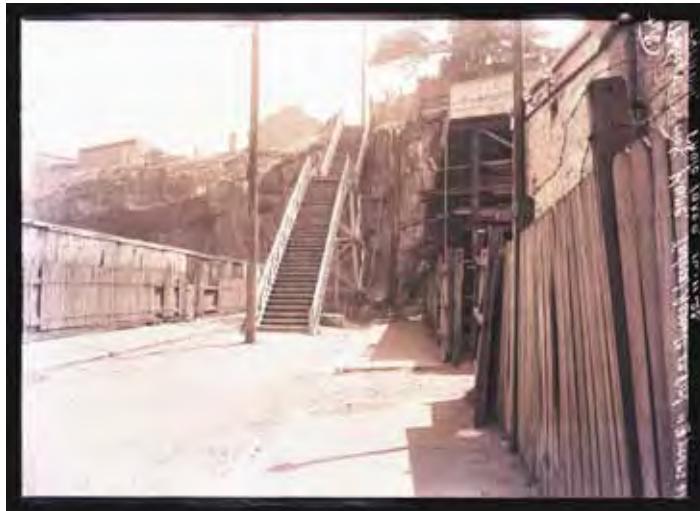
Figure 2: Indecent assault on girl
11 10/12 years, November 14, 1923.
Mount Street, Pyrmont at the corner of
Miller Street.

Now we move to another element of utilitarian built form in the public space of the city and another assault. Whilst for a moment in November 1923 this public stairway was the site of an indecent assault on a girl who may have been as young as 10, this is only one tragic incident in the history of this stairway which was also the site of accidental falls some resulting in death.

This stairway has undergone many transformations. The first version was a timber stairway built in 1887 to a design signed off by R. W. Richards the City Surveyor.²² This first version of the stairway did not last long, and in 1899 a specification was produced by the Sydney City Council “for the Removal and Re Erection of wooden Steps [sic]” in the same location and a drawing again signed by R. W. Richards was produced. The drawing from the City of Sydney archives shows the timber structure of the stairway with a picket style fence on the outside of a cross braced balustrade.²³ In 1903 the stairs were repainted at a cost of twelve pounds and twelve shillings, work that the city building surveyor claimed was “badly needed.”²⁴ In 1914 the timber support trestles and stringers were replaced with iron although the design of the steps and balustrade remained similar. This is the version of the stairway we see in the Forensic Photography archive photograph from 1923.

Apparently neither Robert Saunders nor Albert Sampson were successful with their requests. In 1931 the stair was reconstructed yet again but this time with a structure in mild steel with galvanised iron pipe handrail and a wire mesh balustrade. The steps themselves had hardwood treads and open risers and were fixed to the stringers with steel angles.²⁷

A stairway still exists in this location today, it still has timber treads and open risers with a metal mesh balustrade but today there is a change in direction at the landing so that a hapless pedestrian cannot fall in a straight line all the way from the top. A stair is not a benign component of architectural form. Stairways have been described by the American architect John Templer as "one of the world's most dangerous products."²⁸ Whilst Templer was referring to the stairway as a site of trip hazards and accidental falls, the Forensic Photography Collection illustrates flights of stairs as places not only of accidents but that also have a criminal past as the sites of assault, indecent exposure and murder.

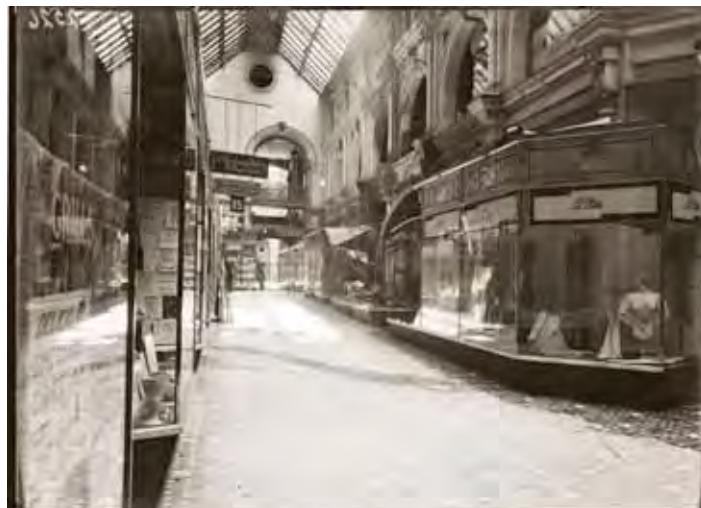
Figure 3. The aftermath of a shopfront fire in the Sydney Arcade around 1937. Details unknown.

The roof structure of the building was wrought iron, with clearstory windows for the full length of both sides of the arcade. These were mechanically openable for ventilation. The floor was finished in encaustic tiles and the arcade was lit with electric lamps.³¹ The electric lighting was such a new phenomenon that it was considered an attraction at the promenade concerts held in the arcade by the proprietors.³² The Gibbs, Shallard & Co. *Illustrated Guide to Sydney* for 1882 described the arcade as “an elegant bazaar” and “a popular promenade.”³³

The fire that resulted in the photograph from the Forensic Archive is possibly that from January, 1939 which reportedly took fifty firemen from six brigades to extinguish and caused fifteen thousand pounds worth of damage.³⁴

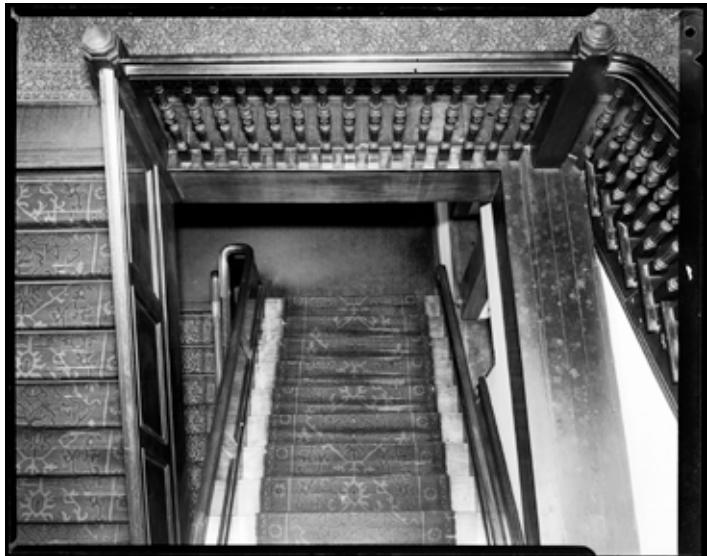
Figure 4: Scene of Death, Hotel Metropole, Sydney City, August 15, 1955.

However this image of its stairway is from the Forensic Photography Archive. The stairway was twenty eight feet by twenty seven feet with the "newels, balusters and handrail ... handsomely carved in blackwood" and with the soffit of the stair "panelled and moulded with selected cedar." I have found no record in newspapers of the death in 1955 for which the photograph was taken but the Hotel Metropole could be a dangerous place. In one week in 1954 three men died in separate incidents there by falling, two by falling down a lift shaft, both on separate occasions and one by falling out a window.

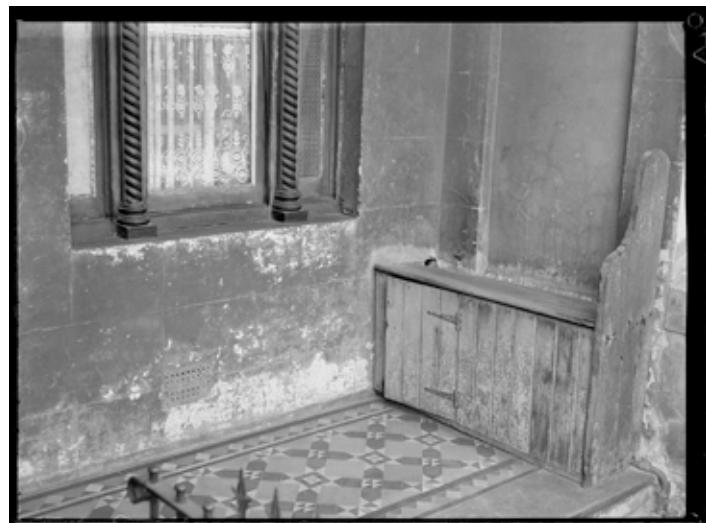
Figure 5. Exterior detail of house in Great Buckingham Street.

The series of photographs relating to the Mrs Grills case show a domestic space of the 1950s. Not the idealised, modern, clean spaces an issue of Australian House and Garden Magazine at the time but everyday domestic spaces where newer styles of furniture and appliances sit side by side with older pieces in an overlaying of domestic technology from different times within a terrace house from the late 1800s. There are details of the outside of the terrace, of the tessellated tiles on the verandah, the cast ironwork, the twisted engaged columns of the three part window, a timber bench with storage space below, that possibly houses the gas meter, the worn paintwork of the rendered and coursed façade and a metal ventilation grille.

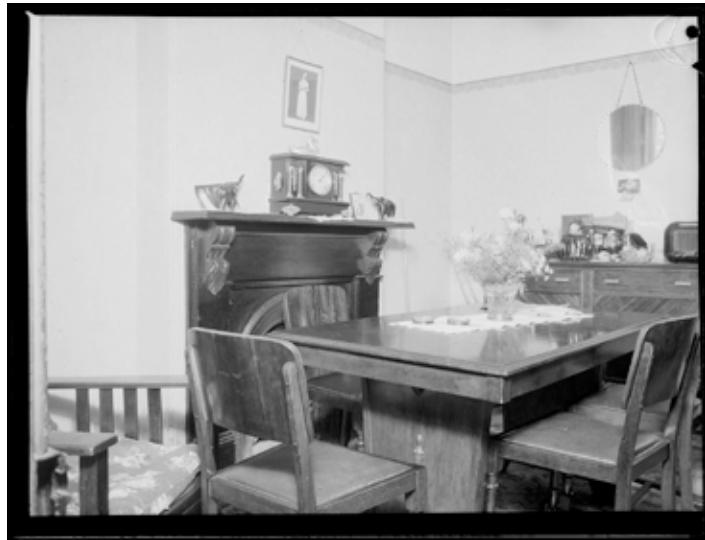
Figure 6. Interior of dining room at a house in Great Buckingham Street.

When the photographer moves inside we are shown a range of the domestic spaces, the lounge, dining room, kitchen and laundry. The dining room contains a Victorian fireplace dating from the time of the buildings construction, but the wallpaper, furniture and Bakelite radio are from a sequence of more recent times.
